SERVICE BULLETIN

NO. A2898-71-1

POWER PLANT - FAN COWLING - HOLD OPEN ROD REPLACEMENT OF SECONDARY LOCK

NORCO INC.

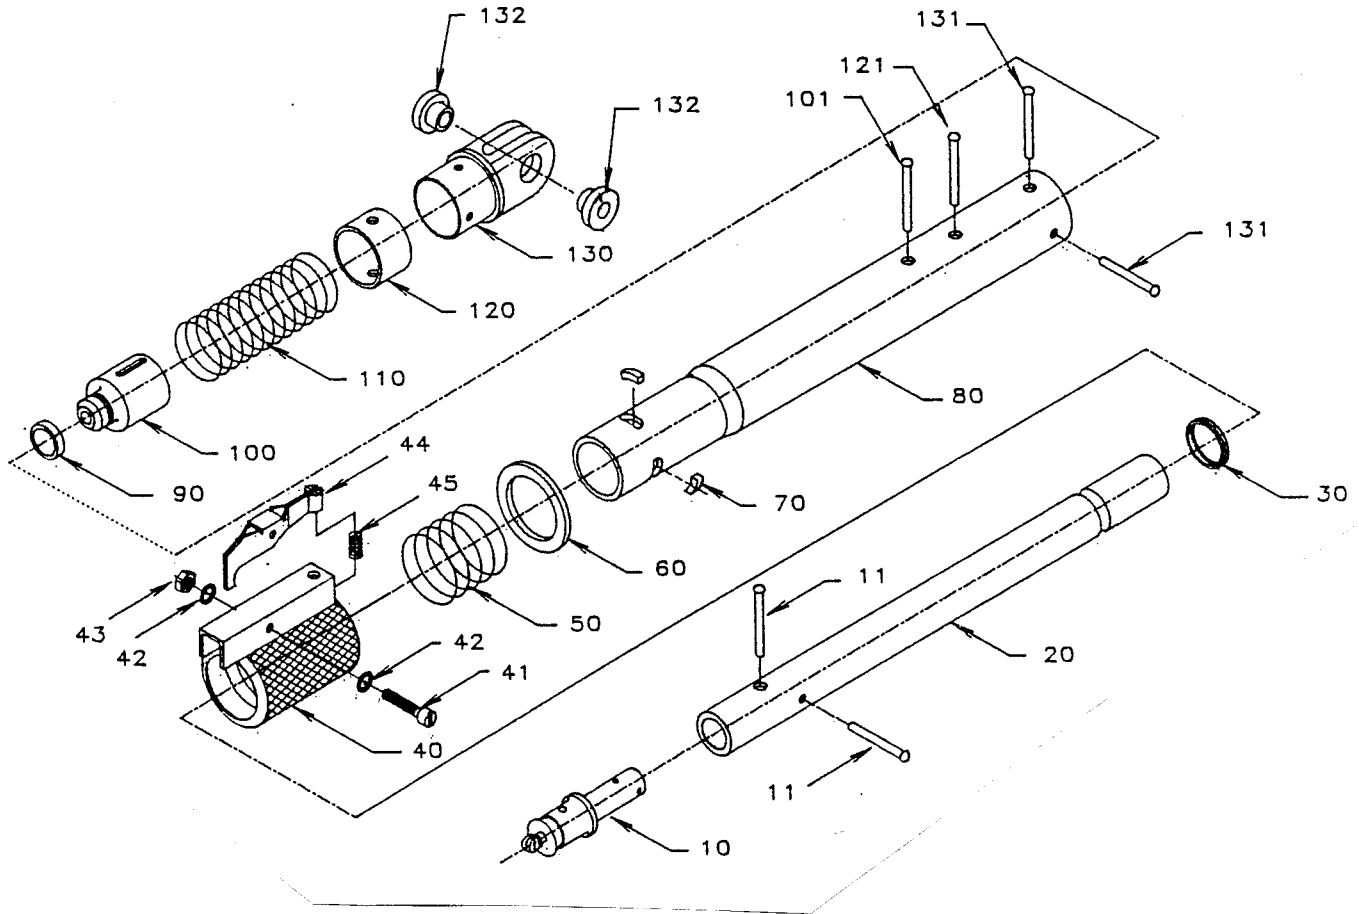
FIGURE 1 - A2898-1 STRUT ASSEMBLY
EXPLODED VIEW

The incorporation of this Service Bulletin will replace the secondary lock with a locking pin to prevent inadvertent unlocking of the hold open rod in the extended and locked position.

A. Disassembly (See Figure 1)

- (1) Remove secondary lock housing from collar (40) by breaking six spot welds along two sides of rectangular housing. Use a hammer and chisel to break welds. Remove sharp edges on broken welds. Scrap housing, safety latch (44, 43, 42, 41), and spring (45).
- (2) Drill out two rivets (131) using a 0.125 inch (3.175 mm) diameter drill. Remove end fitting (130).
- (3) Drill out two rivets (121) and (101) using a 0.156 inch (3.962 mm) diameter drill. Remove plug (120) spring (110) and damper (100) from end of outer tube (80). Check "O" ring (90) for cuts and wear. Replace if worn or cut.
