# SERVICE BULLETIN

## NO. A3068-71-1

POWER PLANT - FAN COWLING - HOLD OPEN ROD  
ROTATE END FITTING 120 DEGREES

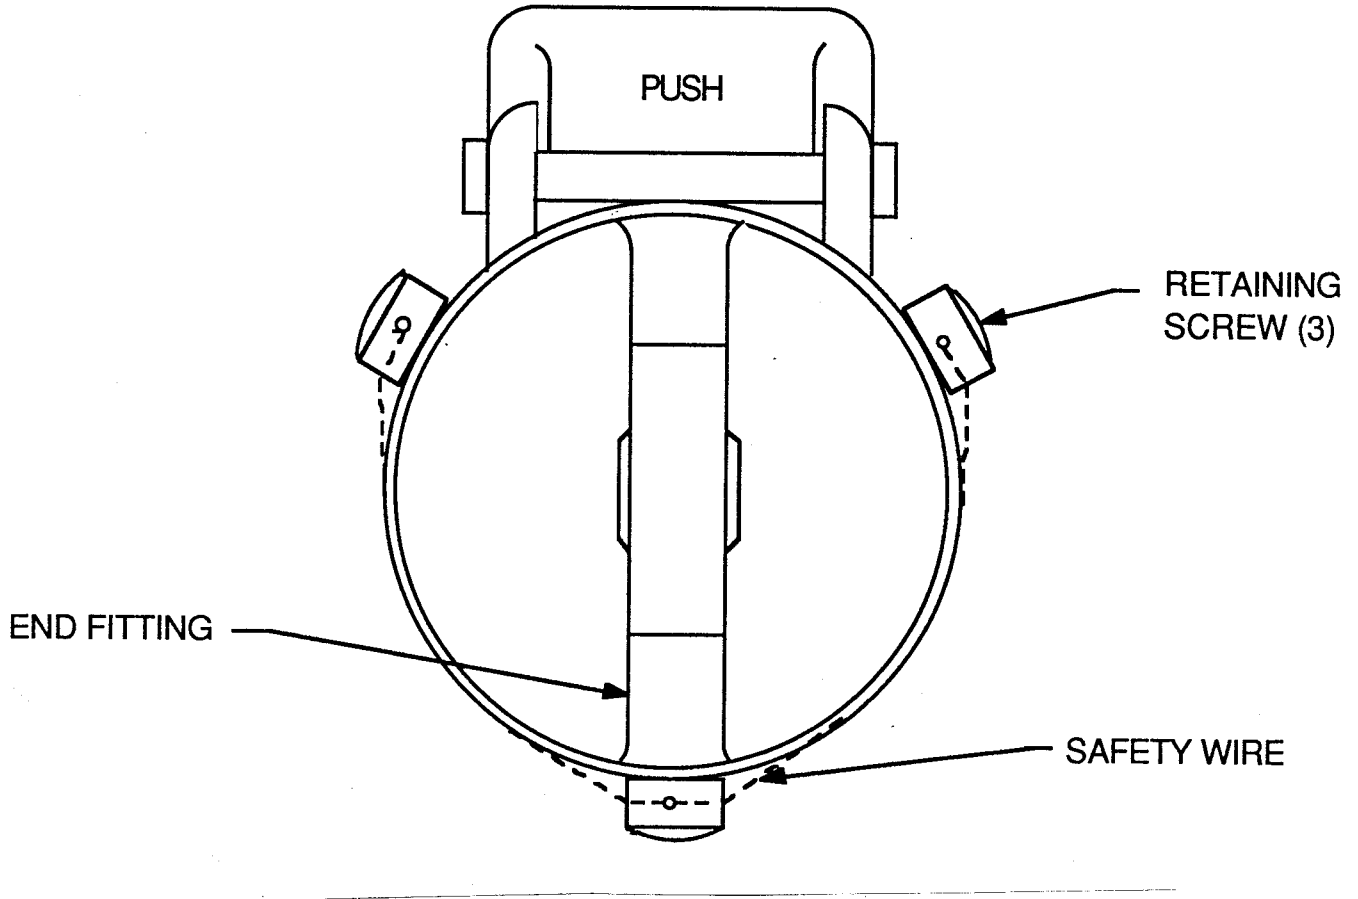
FIGURE 1 - EXISTING A3068-1 END CONFIGURATION

The incorporation of this Service Bulletin will rotate the end fitting 120 degrees to prevent interference with the engine main fuel line.

- (1) Cut safety wire on three end fitting retaining screws and remove safety wire from holes in screws.
- (2) Remove three screws from end fitting by turning counterclockwise.
