# SERVICE BULLETIN

## NO. A3312-71-1

POWER PLANT-FAN COWL-HOLD OPEN ROD  
REPLACE OUTER TUBE RIVETS

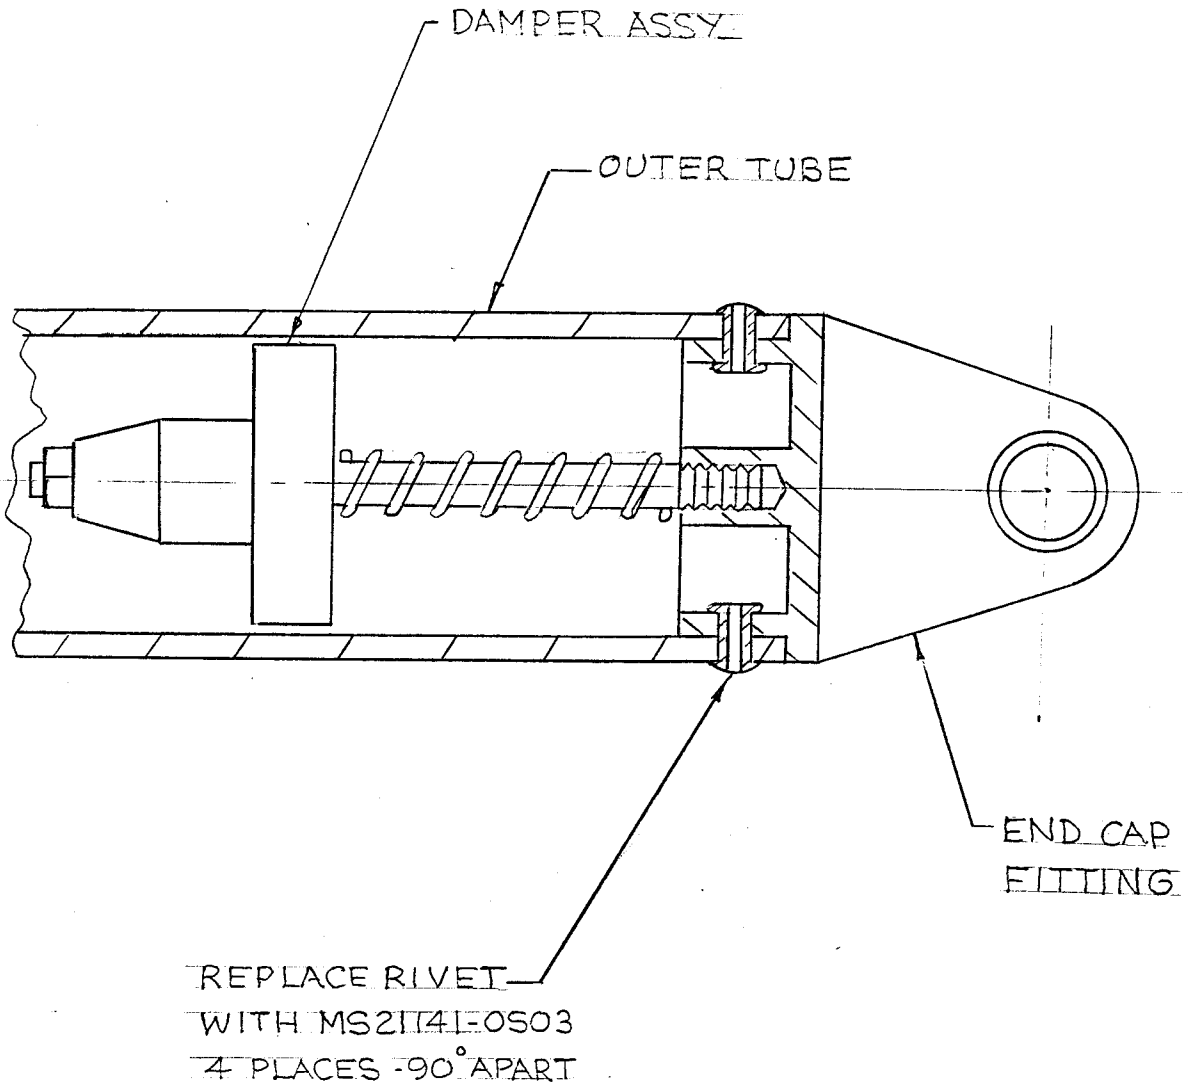
FIGURE 1 — OUTER TUBE AND END CAP

The incorporation of this service bulletin will prevent rivet shear failure due to vibration.

- A. Drill out four (4) rivets in outer tube, shown in Figure 1, using a No. 19 drill (.166 inch diameter).
- B. Place a mark on the outer tube and end cap to indicate alignment of the four holes. Remove end cap assembly from the outer tube.

- C. Remove all metal chips from the end cap assembly and inside of the outer tube.
- D. Place end cap assembly back into end of outer tube and align rivet holes using marks placed on outer tube and end cap before disassembly.

- E. Install four (4) MS21141-0503 rivets using a double action tool as indicated on sheet 1 of the attached Military Standard MS21141.
- F. Clean area immediately following NORCO P/N A3312-1 by rubbing with wiper damped with Aliphatic Naphtha, TT-N-95, or equivalent, until soil is removed. Do not allow solvent to evaporate. Avoid removing pretreatment or finish coating. After soil is removed, wipe the area dry with a clean dry wiper. Using rubber stamp letter size 1/8" to 3/16" and Alcosol or F-100 stamp pad ink, or equivalent, apply the letter "M" immediately following the dash number "-1". Clean stamp with naphtha, or equivalent, as required, for mark legibility and sharpness. Allow ink to dry at least ten minutes and overcoat with Bostik 683-3-2 or 683-3-9 or equivalent.
