## SERVICE BULLETIN

### NO. A361-71-2

Conversion Procedure To Convert Norco Inc. Strut Assembly A361-5 To A361-9

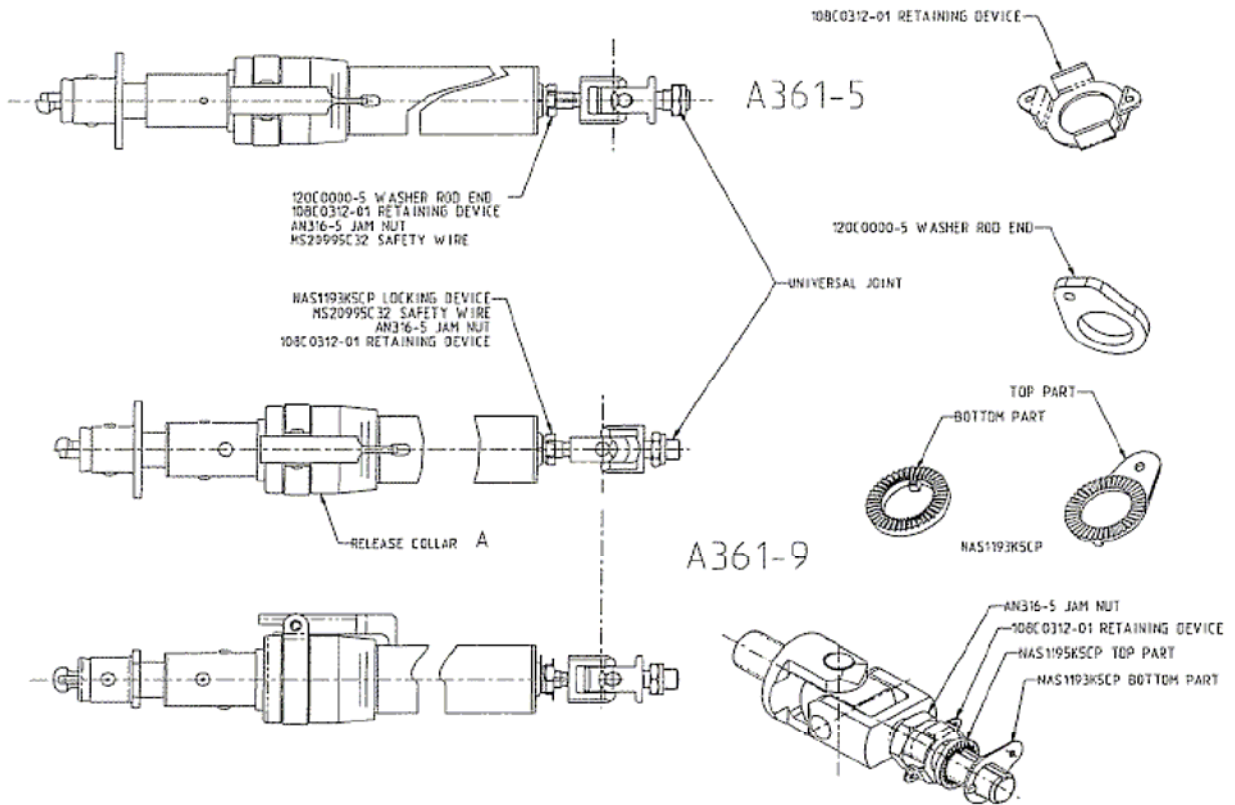
FIGURE 1

This Service Bulletin is to inform all users of the procedures and detailed instructions required for reworking Norco part number A361-5. The reworking requires reorientation of the universal assembly on the A361-5 to the orientation required on A361-9.

- (1) Cut safety wire MS20995C32 and discard.
- (2) Using a .500 open-end wrench, loosen jam nut AN316-5 approximately 4 turns by rotating counterclockwise.
- (3) Slide retaining device 108C0312-01 back with jam nut AN316-5.
- (4) Slide washer rod end 120C0000-5 back out of slot in strut end fitting.
- (5) Remove universal from strut assembly by rotating counterclockwise.
- (6) Discard washer rod end 120C0000-5 and retaining device 108C0312-01.

- (1) Washer rod end 120C0000-5 is to be replaced with NAS1193K5CP locking device.
- (2) Replace jam nut AN316-5 and new retaining device 108C0312-01 on threaded shaft of universal.
- (3) Install bottom part of NAS1193K5CP so that internal key engages key slot in universal shaft with the serrations facing the end of the threaded shaft.
- (4) Position top part of NAS1193K5CP so that serrations are engaged with serrations on bottom part.
- (5) Engage threaded shaft of universal in threaded bore of strut end fitting.

- (6) Thread universal into strut end fitting by rotating clockwise.
- (7) Continue rotating until extended and locked length of  $43.00 \pm .06$  is obtained.
- (8) Adjust position of universal joint as shown on figure 1.
- (9) Engage key on top part of NAS1193K5CP with slot in strut end fitting
- (10) Engage serrations of bottom part with top part.
- (11) Rotate jam nut AN316-5 and retaining device 108C0312-01 together clockwise until contact with NAS1193K5CP is made.
- (12) Torque jam nut AN316C5 to 30/50 lb.-in.
- (13) Install new safety wire MS20995C32 in accordance with MS33540.
