MarathonNorco Aerospace, Inc. 8301 Imperial Drive Waco, Texas 76712-6588

SERVICE BULLETIN

SB-SS112-52-1 Revision 2

Subject: Product Improvement – Escape Slide/Raft – Add Positive Lock to Packboard Latch

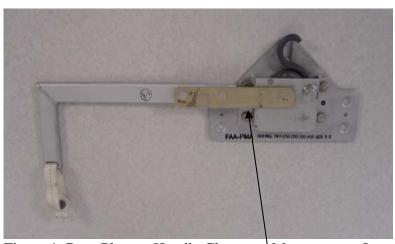
Figure 1. Base Plate to Handle Clearance Measurement Location

- a. Orient the SS112A1 or SS112A11 assembly so that it can be viewed in the locked position.
- b. Ensure that the release arm is in the locked position.
- c. Measure the clearance between the handle and the base attachment plate of the assembly at the edge of the base plate as shown in Figure 1.

- d. If the nominal measurement exceeds 0.290 inches then the part must be returned to the manufacturer for rework.
- e. If the measurement is 0.290 inches or less then rework following the procedure outlined in Part 3 of this section.
